Kanawat Health Centre

Improvement of Sanitation Infrastructure

January – July 2004

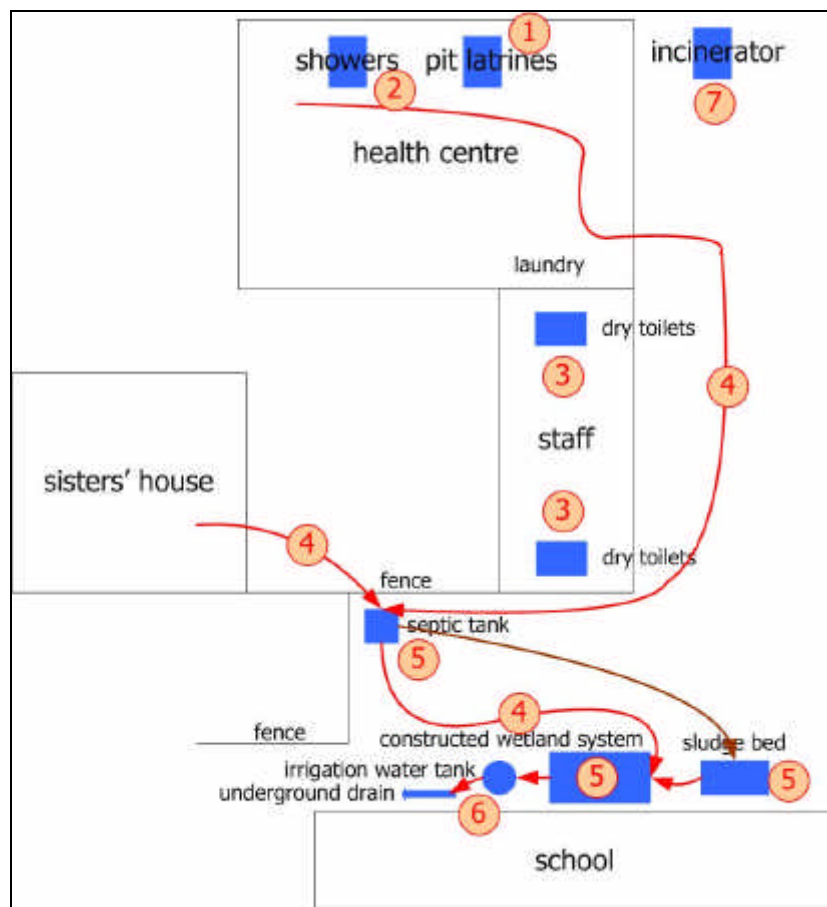
Figure 1: Overview about the project components.

1. Renovation and reconstruction of pit latrines / composting toilets
2. Renovation of showers/washing place and connection to sewer line
3. Construction of a dry toilet block with 4 doors
4. Construction of sewer line and
5. house connections (incl. bypassing of existing septic tanks and soak pits)
6. Construction of a wastewater treatment system comprising a septic tank for pre-treatment, a horizontal subsurface flow constructed wetland system for secondary treatment, a sludge drying bed for sludge from the septic tank (to be discharged by gravity)
7. Construction of a low cost medical waste incinerator
8. Awareness creation, capacity building and training

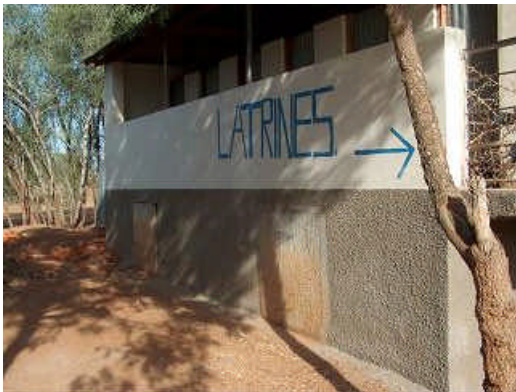
Toilets for patients attendants were available on the health centres' compound in the form of pit latrines. Due to underground conditions (hard rock) it was not possible to dig sufficiently deep pits. Thus the toilet slab was raised app. 1,20m above ground level to achieve a

sufficient storage volume and to make emptying easier. In the immediate vicinity of these pit latrines shelters were available for the patients attendants to be used as showers (which were misused for defecation). The Health Centre staff was using pit latrines which are located near the staff houses.

Picture 1: Raised pit latrine for patients attendants.

To avoid all problems connected with pit latrines (smell, flies, potential ground water pollution, etc.) the existing raised pit latrines were reconstructed as dry toilets. Following discussions with the administration and the technical personnel on site it was decided to construct composting toilets for various reasons:

- ✓ the present construction allows the creation of a sufficiently large storage volume
- ✓ composting toilets can be used like pit latrines by the patients attendants
- ✓ maintenance in order to assure proper conditions for composting can be carried out by the technical staff on site
- ✓ the final product can be reused or dumped without additional storage or treatment

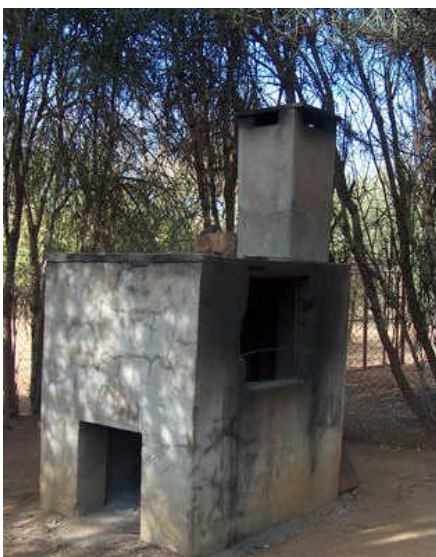
In addition also the incinerator for the medical waste was located on the small compound of the Health Centre. Due to the broken construction of the incinerator, black and densely smoke was polluting the air and insufficient burnt medical waste was dumped uncontrolled.

Picture 2: Old medical waste incinerator.

In order to be able to dispose of health care waste in a safe way to replace the old medical waste incinerator was necessary. To reduce both investment and running cost a low cost medical waste incinerator based on a project of the Applied Sciences Faculty of the De Montfort University in Leicester was constructed. A covered and fenced dumping area for the burned ashes was constructed additionally in the Health Centres compound (on request of the project, but was not included) for a safe disposal of the burnt residues.

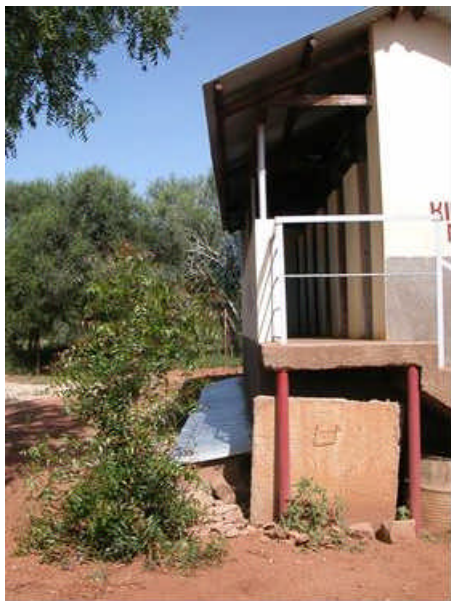
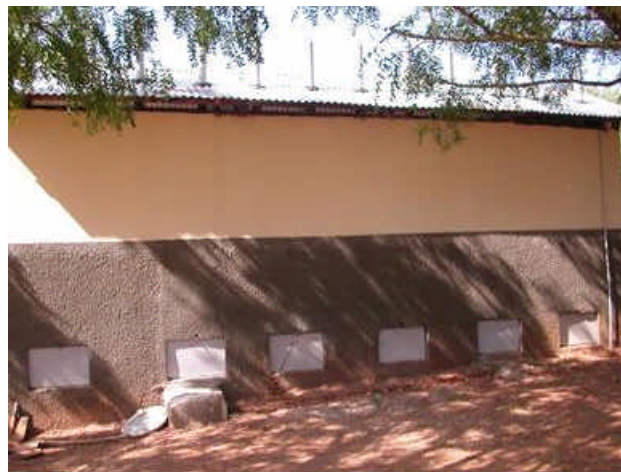
Picture 3 / 4: Reconstructed composting toilet for patient attendants.

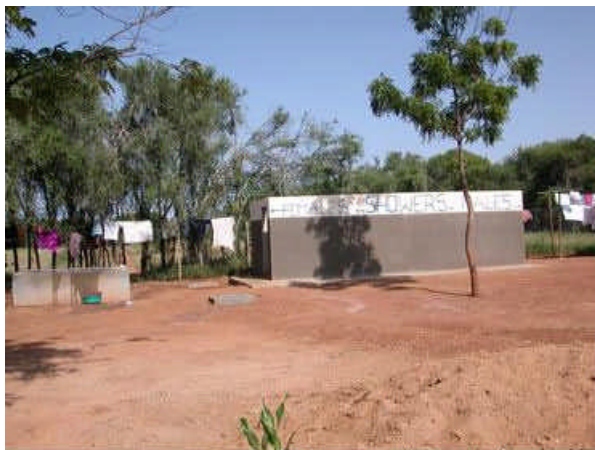
Due to the general poor state of the old showers new units were constructed as well as a washing place for washing cloth. Both units were connected to the sewer line, in order to avoid mosquito breeding and groundwater pollution.

Picture 5: Showers and washing place for cloth.

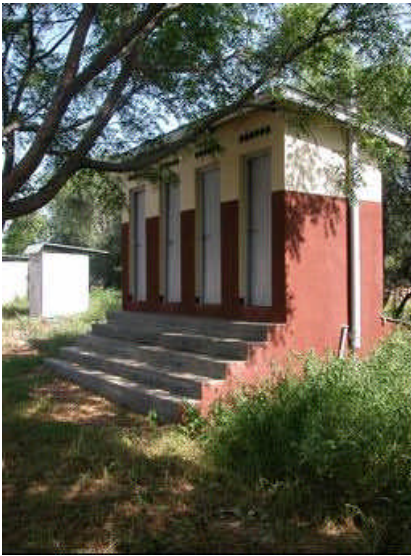
In order to avoid the problems related to pit latrines on the one hand and to demonstrate modern technologies on the other hand dry toilets (diversion toilets) were constructed. The final design of the toilets was discussed before construction in detail with the users of the units. The required awareness creation activities were carried out by the technical personnel of the Health Centre together respectively additionally of the EcoSan Club.

Picture 6: Dry toilet for Health Centre staff

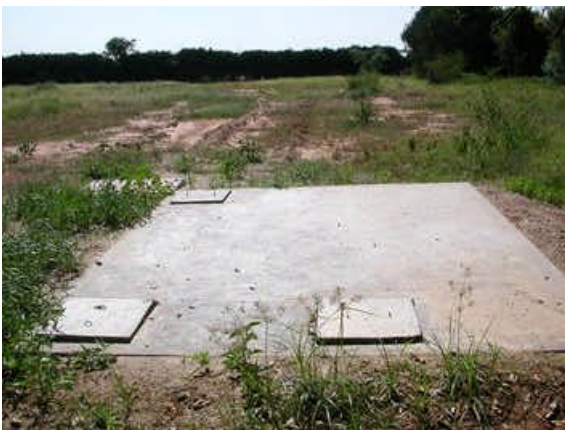
first mechanical treatment step consists of a septic tank where solid particles are separated by gravity and stored before being discharged to the sludge bed for further stabilisation and storage. Discharge of the sludge to the sludge beds is being done by gravity every 3 months.

Picture 7: Septic tank for pre-treatment of wastewater.

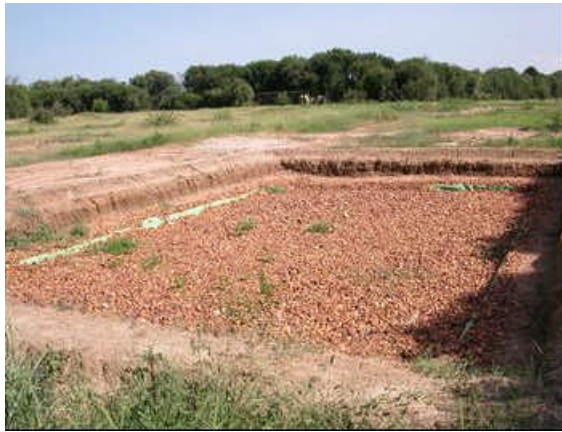
The outflow of the septic tank is further purified in a horizontal subsurface flow constructed wetland system before the treated wastewater is collected in an irrigation tank.

Picture 8: Horizontal flow constructed wetland.

A concrete tank was positioned at the lower end of the constructed wetland system to allow storage of treated wastewater for reuse as irrigation water. The water tank is designed to store the maximum daily wastewater flow which has been estimated to 5m³. Surplus water will overflow to a subsurface percolation trench. Its recommended to use the treated wastewater to irrigate fruit trees or any kind of plants which are not used for food production.

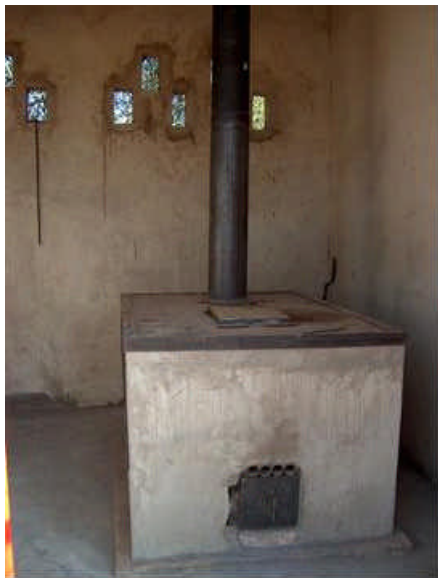
Picture 9: Low cost medical waste incinerator.
